# **Review of Water Quality and Impact to Wetlands of Proposed Development in Spruce Creek, Florida**

**Report on Phase 1 of Scope of Work  
June 2020**

*"Coastal Risk Consulting, LLC"*  
**2385 NW Executive Center Drive, Suite 100, Boca Raton Florida 33431, USA**

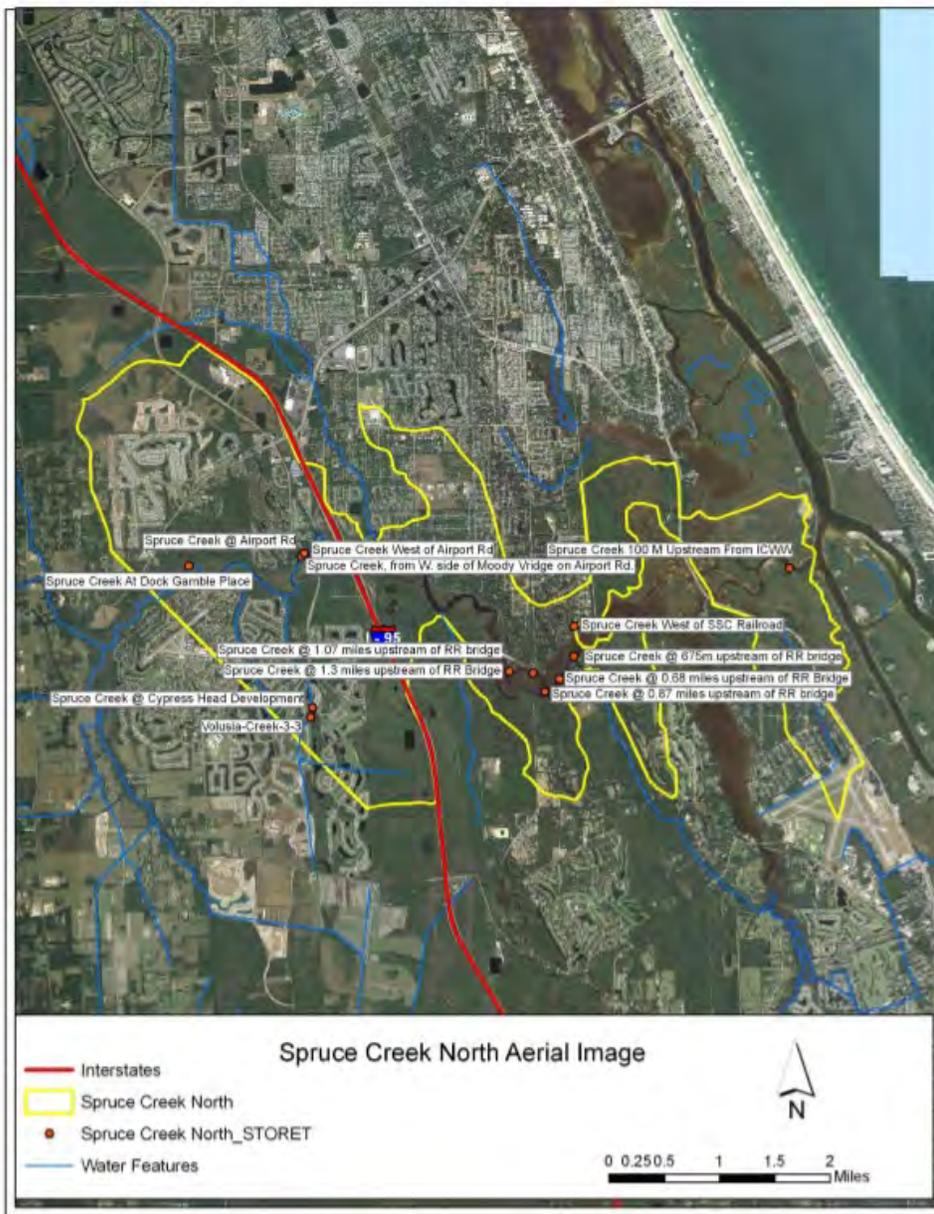
Figure 2: Historical sampling sites in Spruce Creek

We reviewed data in available TMDL reports, the [TMDL report](#) on the 2008 study and other documents provided by SSC. **We observed there was limited information available up to 2014 and, no evidence of any water quality studies in Spruce Creek after 2014. Some readings for dissolved oxygen content and nutrients are available up to 2016.** In addition, we also reviewed information on water quality on the websites of St. Johns River Water Management District and DEP. We focused on data derived from 5 basin stations relating to impairment of water quality from (1) Fecal Coliform, (2) Dissolved oxygen, and (3) nutrients (phosphorus and nitrogen). The locations of these 5 stations are given in Table 1.

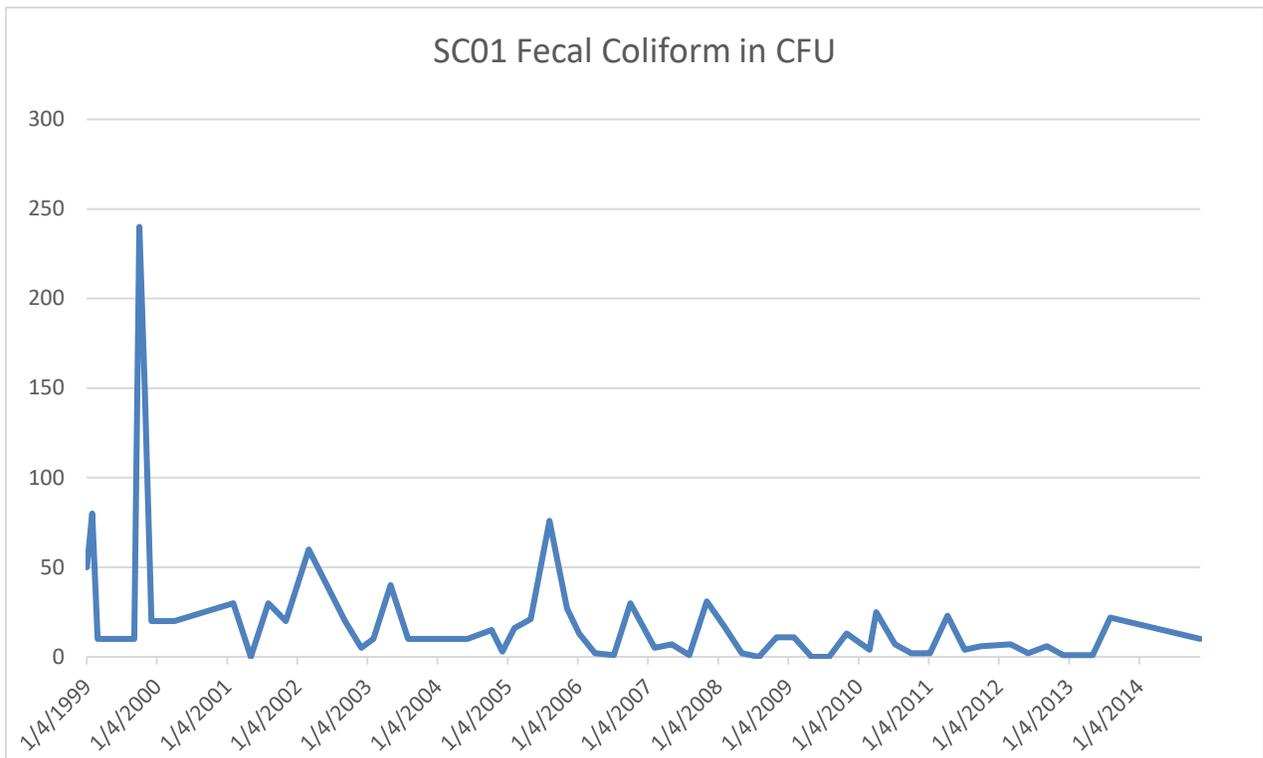
Figure 3: SC01 Fecal Coliform

Data on fecal coliform from the different basin stations in Spruce Creek from 1999 to 2014 was analyzed in the form of graphs for each station as shown below. The red line denotes the standard of 400 CFU per 100 ml.

Recent data (up to 2014) indicate that fecal coliform counts have been under the maximum value of 400 CFU/100 ml, indicating that the water samples met Class III criteria at that time. Given the long-term record of readings intermittently above 400 CFU/100 ml (see graphs below) and the continually increasing presence of non- point sources, **more recent data needs to be acquired to determine the degree of impairment.**

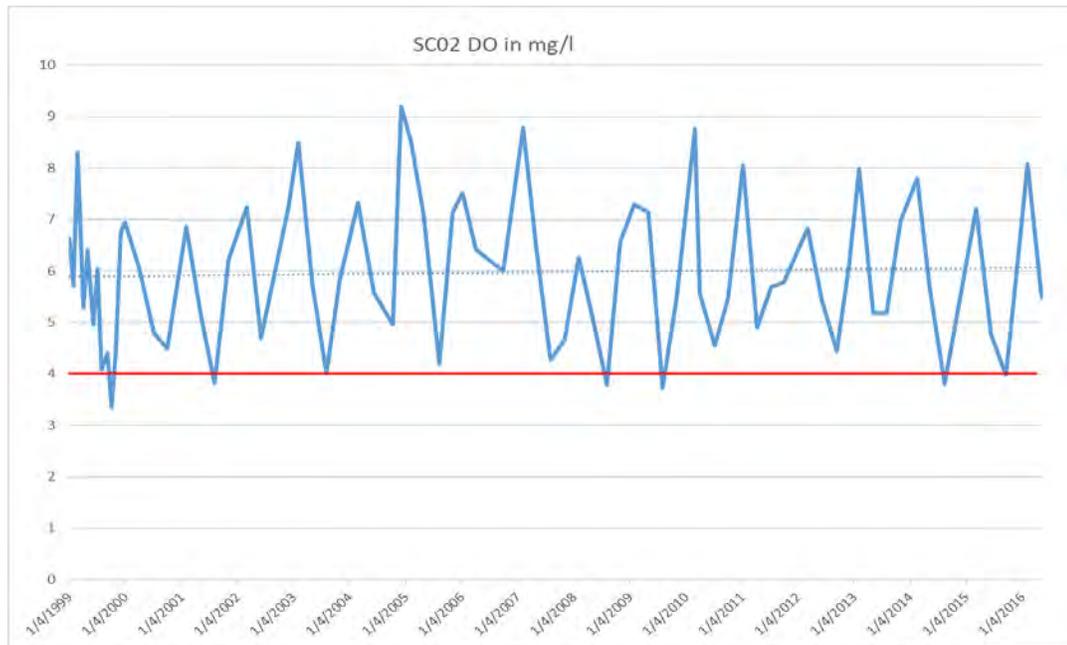
Figure 8: SC02 DO

Data on dissolved oxygen and nutrients from the different basin stations in Spruce Creek from 1999 to 2014 was analyzed in the form of graphs for each station as shown below. The red line denotes the standard of 400 CFU per 100 ml.

According to EPA’s Class III [guidelines for Florida waters](#), the 7-day average Dissolved Oxygen (DO) saturation should be not less than **51% or about 4 milligrams per liter (mg/l)** in 85°F temperature. However, related data is only available for one or two days a month. **It was, therefore, not possible to get an average 7-day value. Only three stations have recorded samples after 2008.** DO values in stations SC02 and SC04 are available until 2016 and appear to be above the minimum of 4 mg/l. DO values for SC05 have been below 0.5 mg/l in observations recorded from 1999 to 2006 and DO values for SC06 between 2005-2010 have generally been under 4 mg/l.

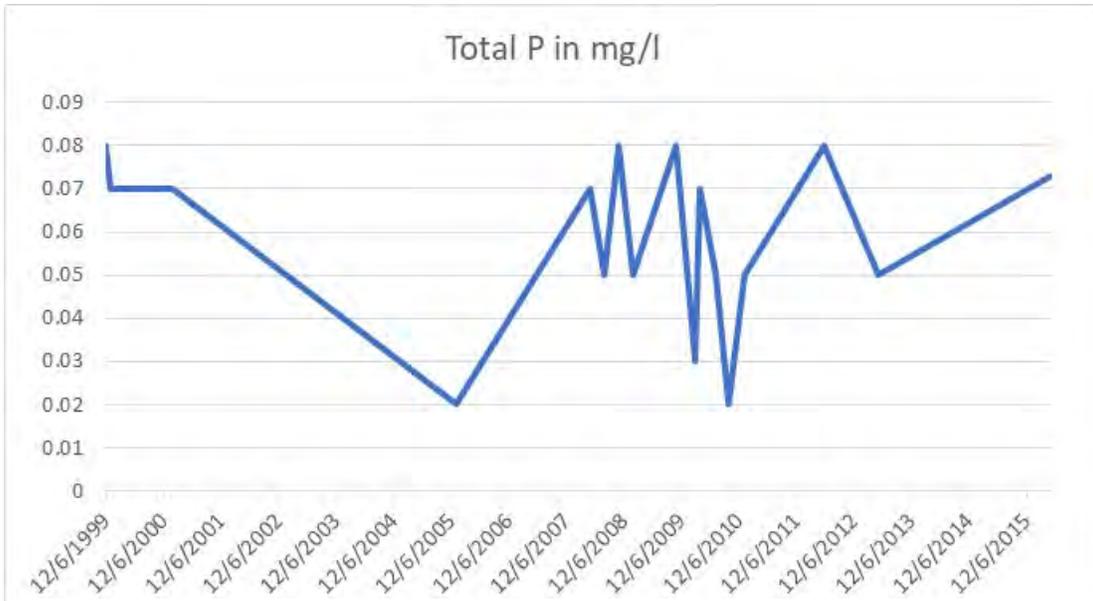
Figure 12: SC01 P

Per Florida Administrative Code 62-302.531, given the availability of site-specific TMDL nutrient criterion for Phosphorus, [Total P values for](#) Class I-IV waters should not be more than 0.16 mg/l. However, as seen in the data from the graphs below, all stations except SC01 show values higher than 0.1mg/l after 2008. In case of SC02 and SC04, while values are higher than 0.1mg/l, the trend shows a decrease in P from 2008 to 2016. In case of SC06, between 2008-2010, the P value trend line is above 0.1 mg/l. The red line denotes the standard of 0.1 mg/l.

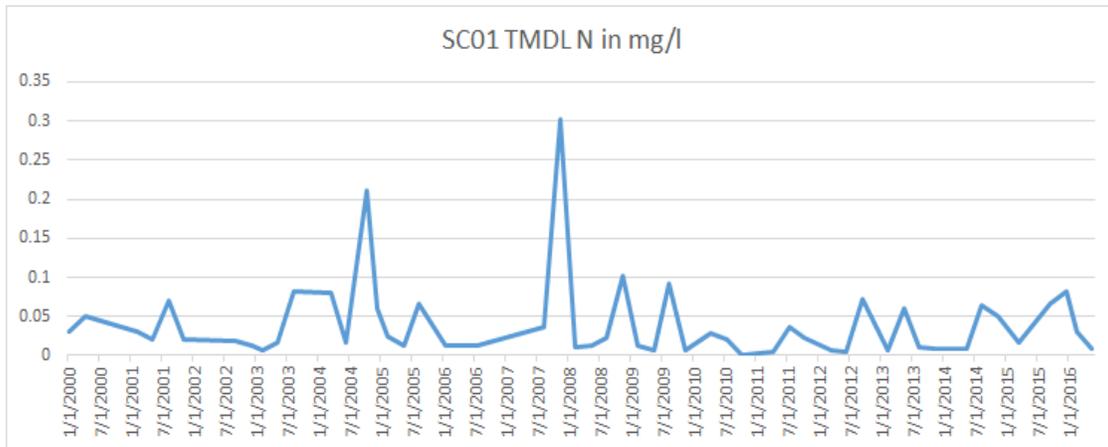
The data available for Nitrogen contents at the Basin Stations, expressed in milligrams per liter, are presented in the graphs below. However, there is no numerically interpreted direct criterion for nitrogen in EPA or DEP guidelines. Nitrogen, like Phosphorus, is considered a nutrient and the nutrient criterion is based on the annual mean chlorophyll levels.

Figure 17: SC01 Total N in mg/l (excluding abnormal 1/4/1999 reading)

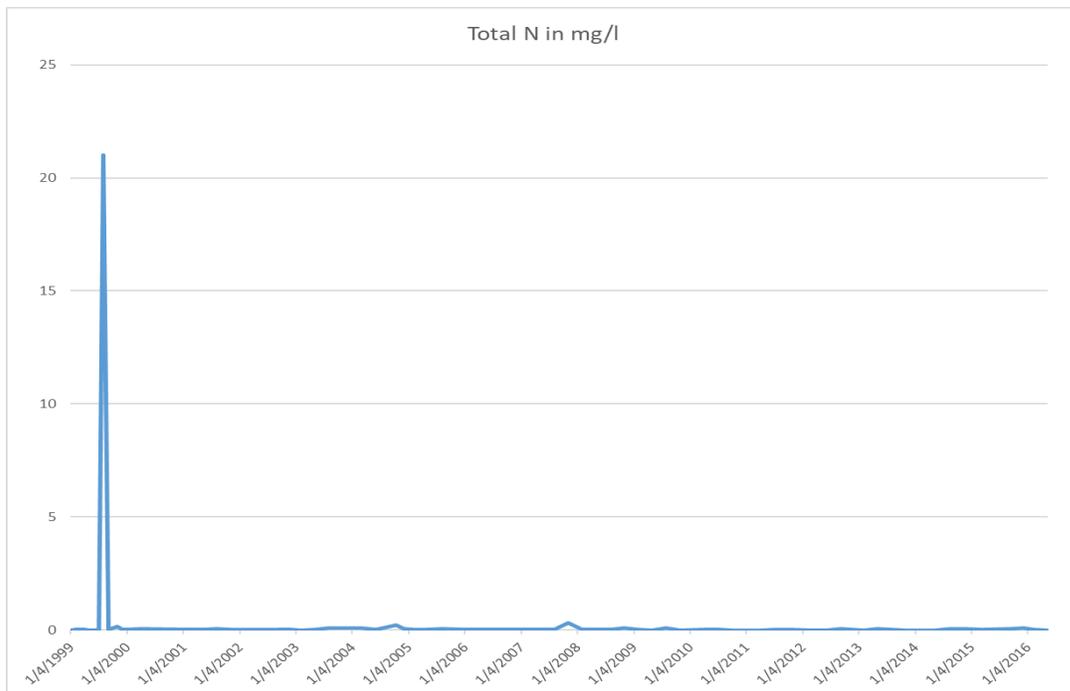
Figure 18: SC01 Total N in mg/l (including abnormal 1/4/1999 reading)

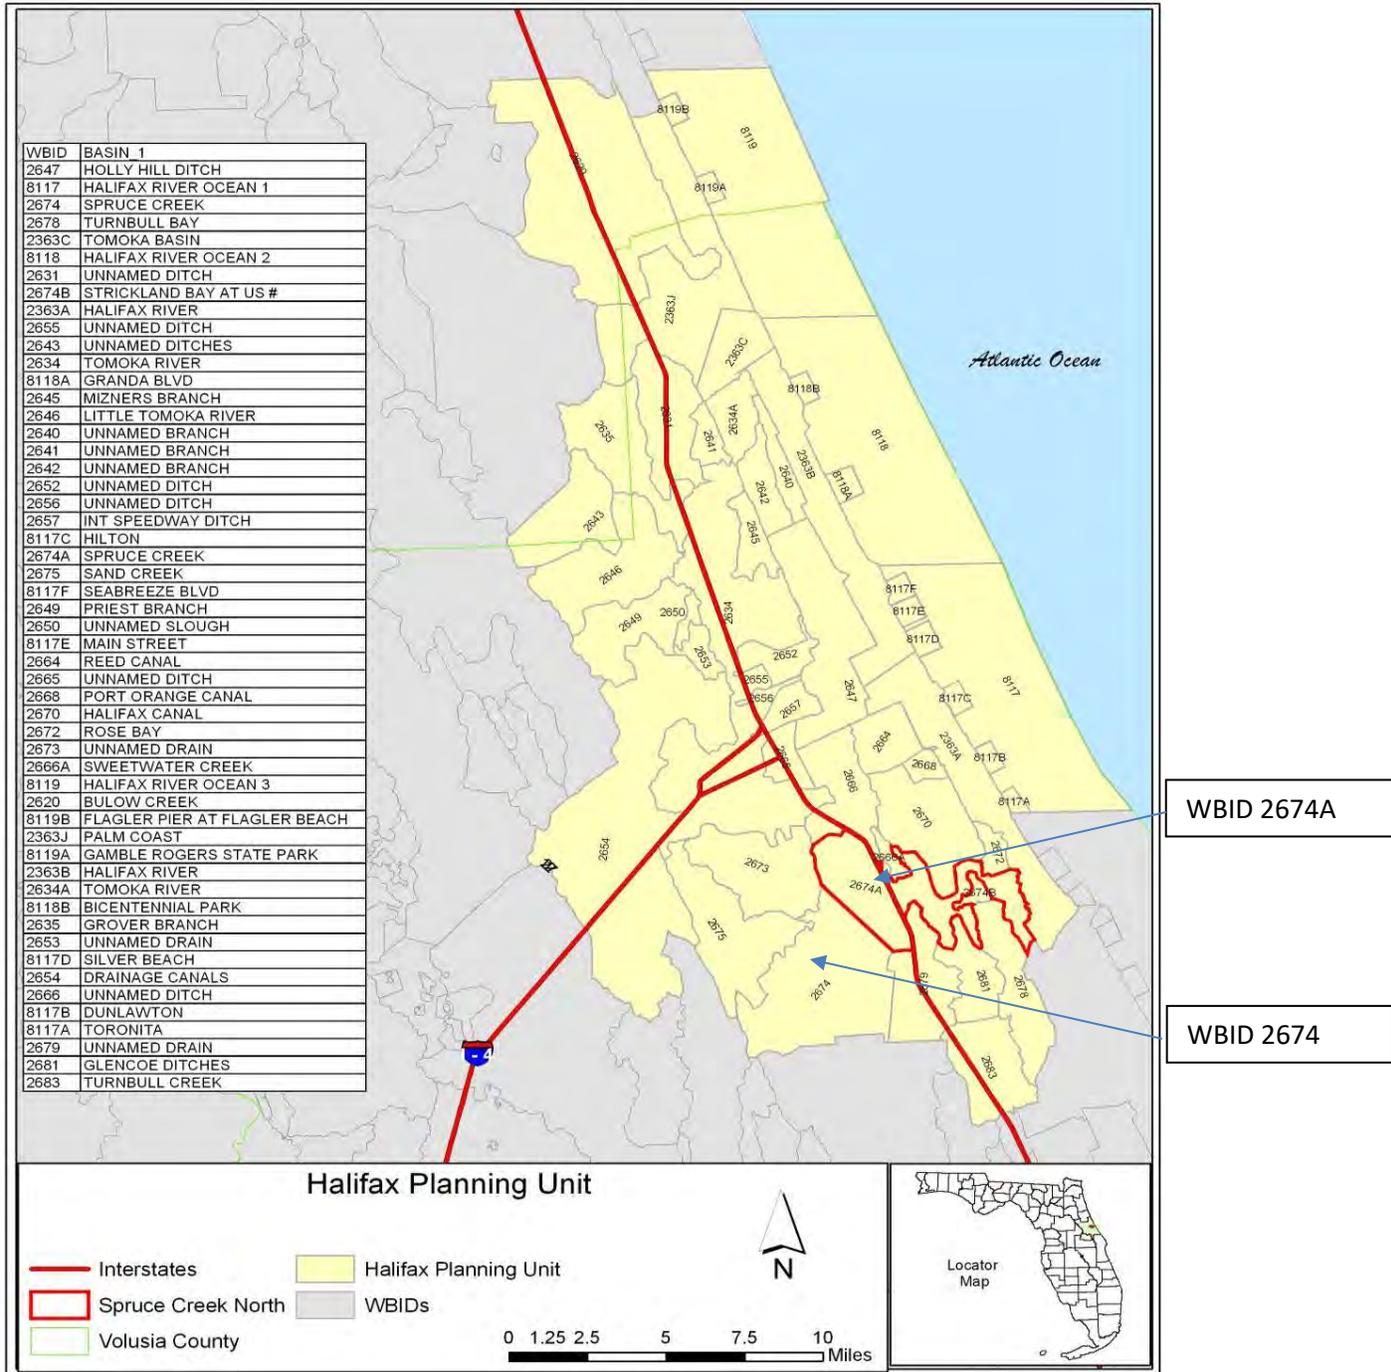
Figure 23: WBIDs in Halifax River Planning Unit

As shown in Figure 1 above, Spruce Creek consists of two segments, WBID 2674 and WBID 2674A. The TMDL Study of 2008 addresses the DO and nutrient impairments in WBID 2674A. For assessment purposes DEP has divided the Upper East Coast Basin into water assessment polygons with a unique waterbody identification (WBID) number for each watershed or stream reach. Spruce Creek is part of the Halifax River Planning Unit. Planning Units are groups of smaller watersheds (WBIDs) that are part of a larger basin unit, in this case the Upper East Coast Basin. The Halifax River Planning Unit consists of 53 WBIDs. Figure 23 below shows the locations of these WBIDs.

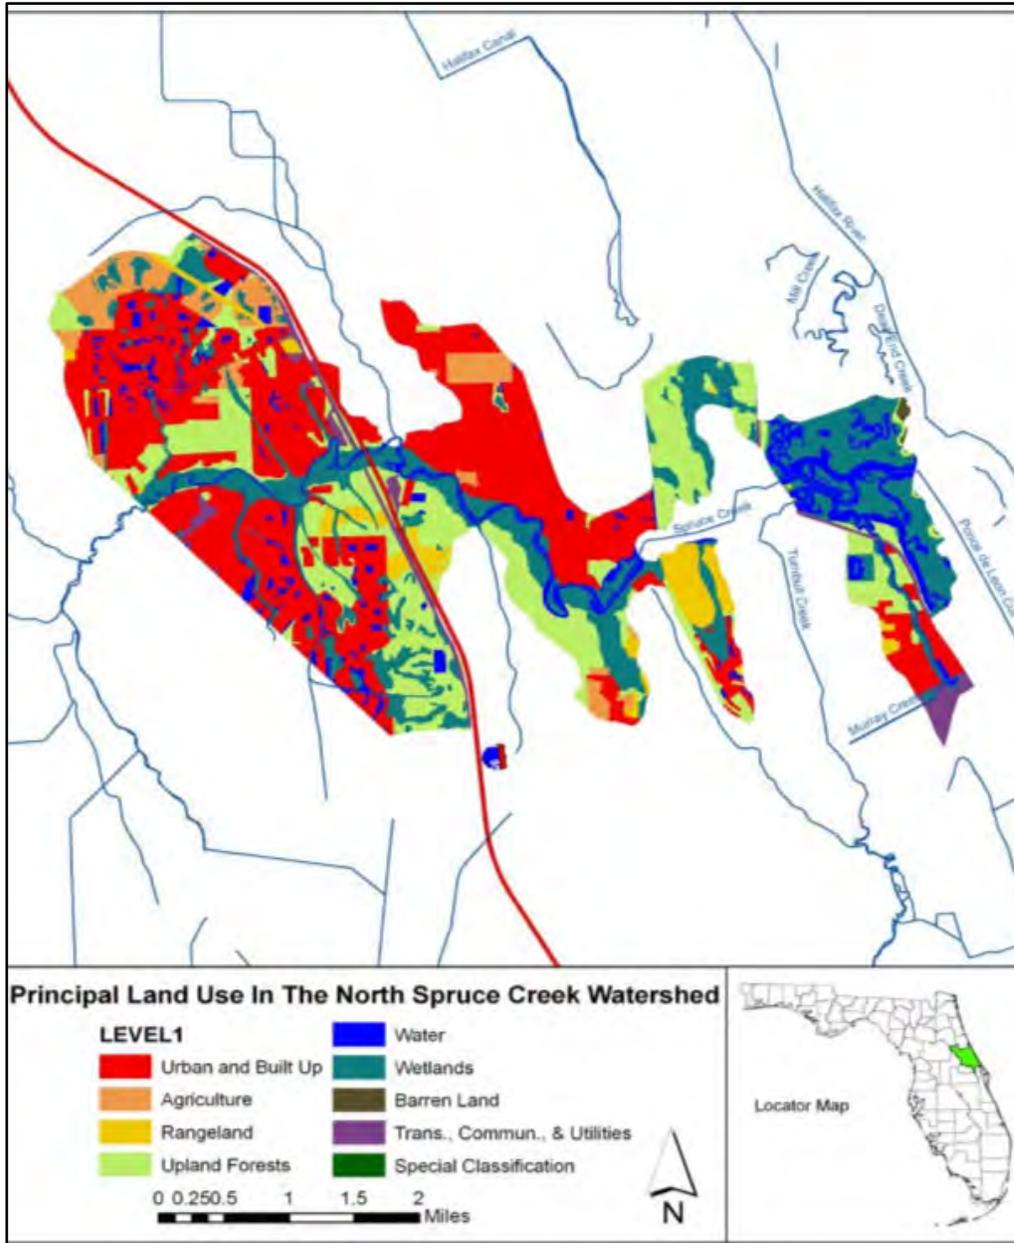
The Spruce Creek Watershed is an area that is facing increased development pressures. According to Table 5 and Figure 31 below, urban and built-up areas already represent 38.4 percent of the area, medium-density residential represent 14.8 percent, followed by forest 22.2 percent, and wetlands only 21.3 percent. **Source:** Final TMDL Report, 2008

Figure 31: Historical Land Use in Spruce Creek WBID 2674A watershed
